Appendix H

INTERIM REPORT ON EVOLUTION OF WTC FIRES, SMOKE, AND DAMAGE BASED ON IMAGE ANALYSIS

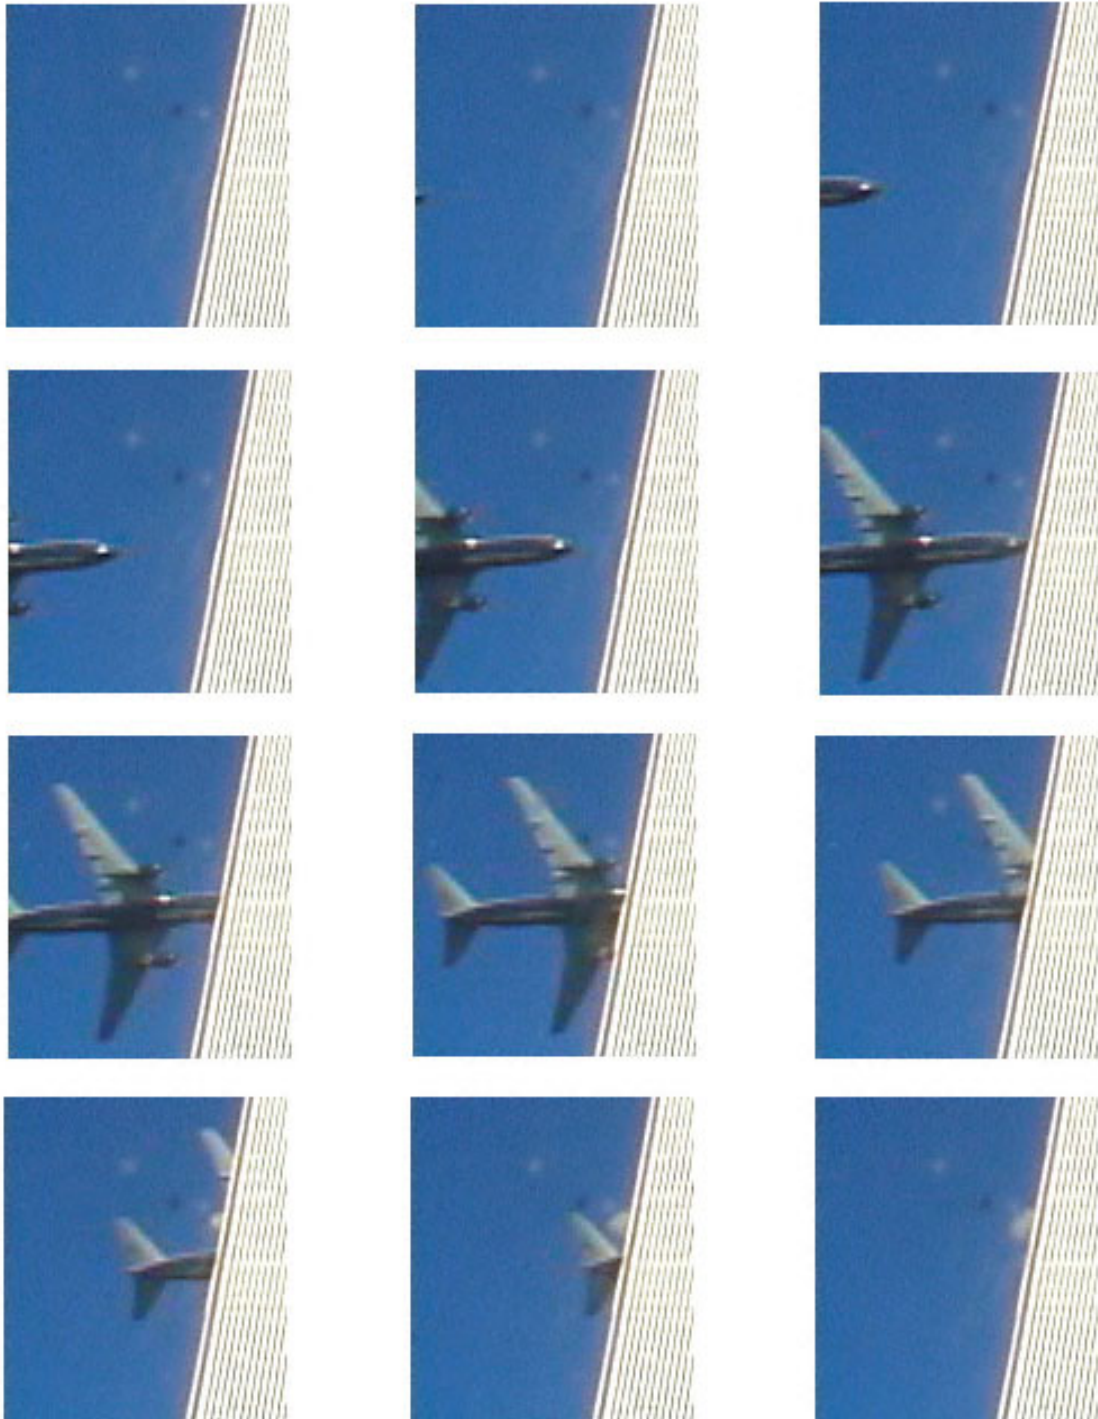
Figure H-15. Series of sequential cropped frames taken from a video shot on September 11, 2001, showing the plane approaching WTC 2. The frames, ordered from left to right and top to bottom, are separated by 33.3 ms.

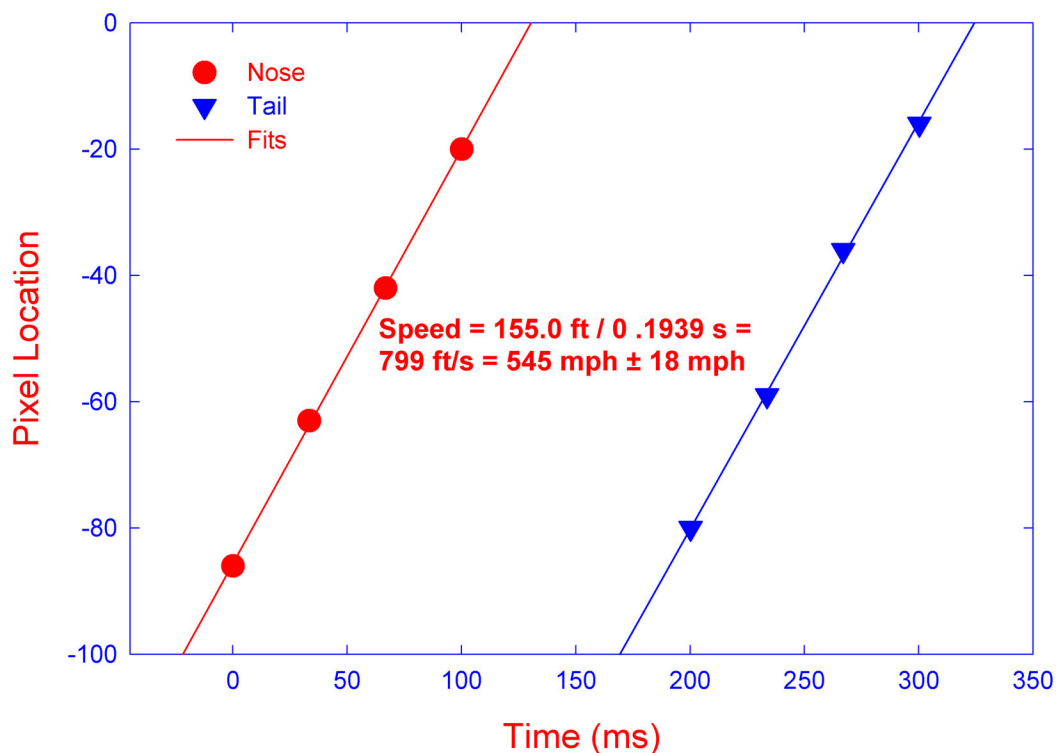
Figure H-16. Plots of pixel locations for the nose and tail of the plane that struck WTC 2 as a function of time taken from the images shown in Fig. H-15. Straight lines are the results of linear least squares curve fits to the data. Extrapolation of the lines to pixel 0 allows the time for the passage of the plane to be calculated.

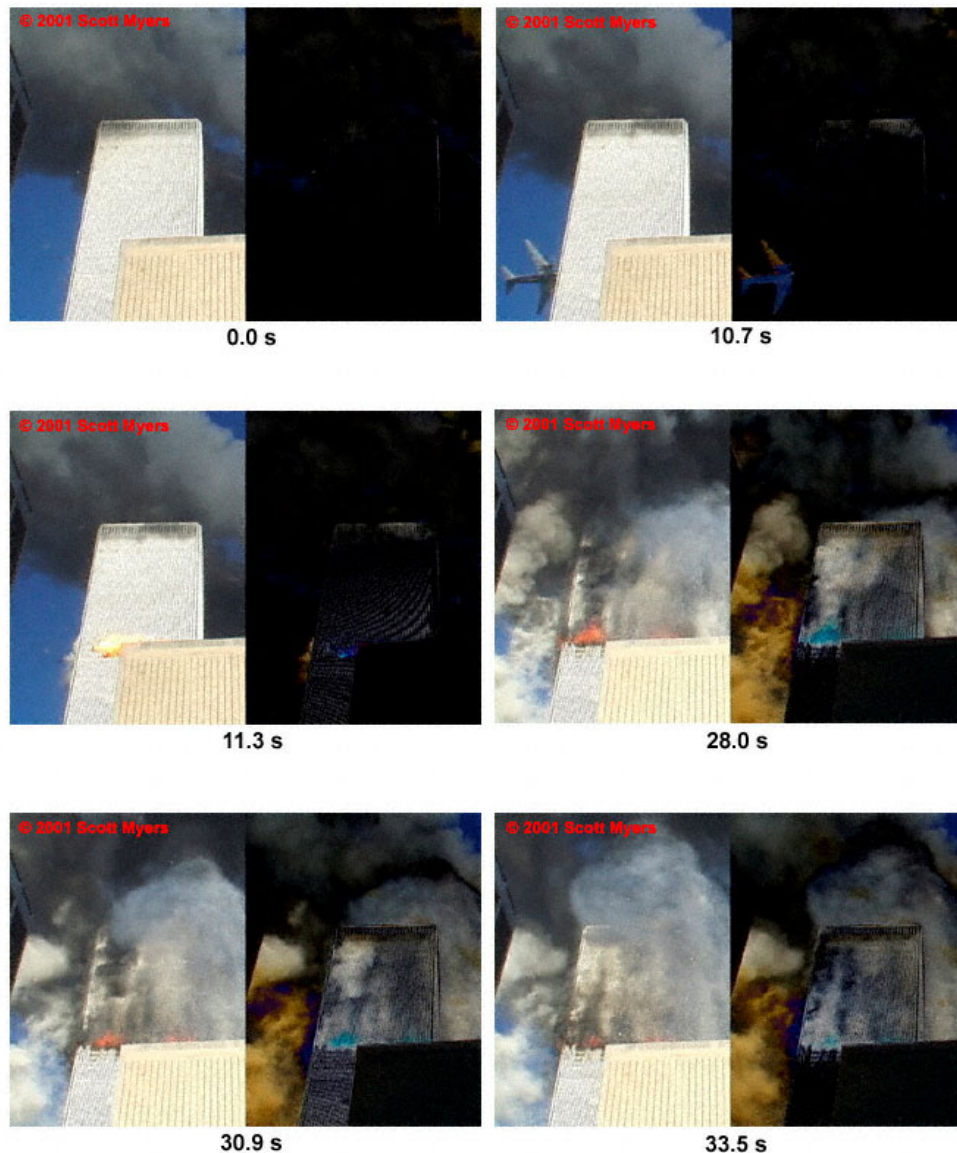
analysis was used to enhance this motion and estimate the period required for the building to sway through one complete cycle. This was accomplished by creating a new video in which a single frame just prior to the plane strike was subtracted from subsequent frames. In this way, small differences between images can be identified. If the image is unchanged from the initial frame, the result should be a black image, but any changes in location or color will appear in the difference video. When this approach was applied to the video, a region of windows was observed on the building that seemed to appear and disappear. Figure H-17 shows several frames of a composite video formed by overlaying half frames of the original video and the difference video. In the initial frame (time = 0.0 seconds), the plane has not yet appeared and the difference frame is black. In the next frame (time = 10.7 seconds), the plane is approaching the building. The plane is evident in the difference frame since it represents a change in the frame. WTC 2 is still dark except near the top where changes due to smoke movement are apparent. In the third frame (time = 11.3 seconds), the plane has struck the building and dramatic changes in the appearance of the building façade in the difference frame occur. Careful inspection shows what appear to be curved lines running across the face of WTC 2. These curves result from an interaction between the straight lines formed by the windows on the tower and the straight lines of picture elements that make up the detector in the digital video camera. This well-known behavior is called the moiré effect. The moiré effect also provides a sensitive approach for determining the displacement of the building. Such an analysis is in progress and will be reported at a later time.

Figure H-17. Frames from a composite video are shown. The half frames on the left are taken from a video showing the plane strike on WTC 2, while the half frames on the right are generated by subtracting a frame recorded prior to the plane strike from all subsequent frames in the original video. Times refer to the period since the start of the difference video.

Following the plane strike, areas of the tower face above the strike floors become hidden by smoke, and it is difficult to see the moiré patterns in the difference frames. However, the area of the tower below the strike floors to the left of the building in the foreground continues to show a distinct difference pattern because it is not obscured by smoke. This pattern is apparent in the fifth frame (time = 30.9 seconds). On the other hand, frames 4 and 6 (times = 28.0 seconds and 33.5 seconds, respectively) have been chosen because they are near null points, and the area appears dark in the difference frame because the location of the building is essentially unchanged from its position before the plane struck. When the video is

played, the moiré patterns in this area of the tower face alternately appear and disappear in the difference video.

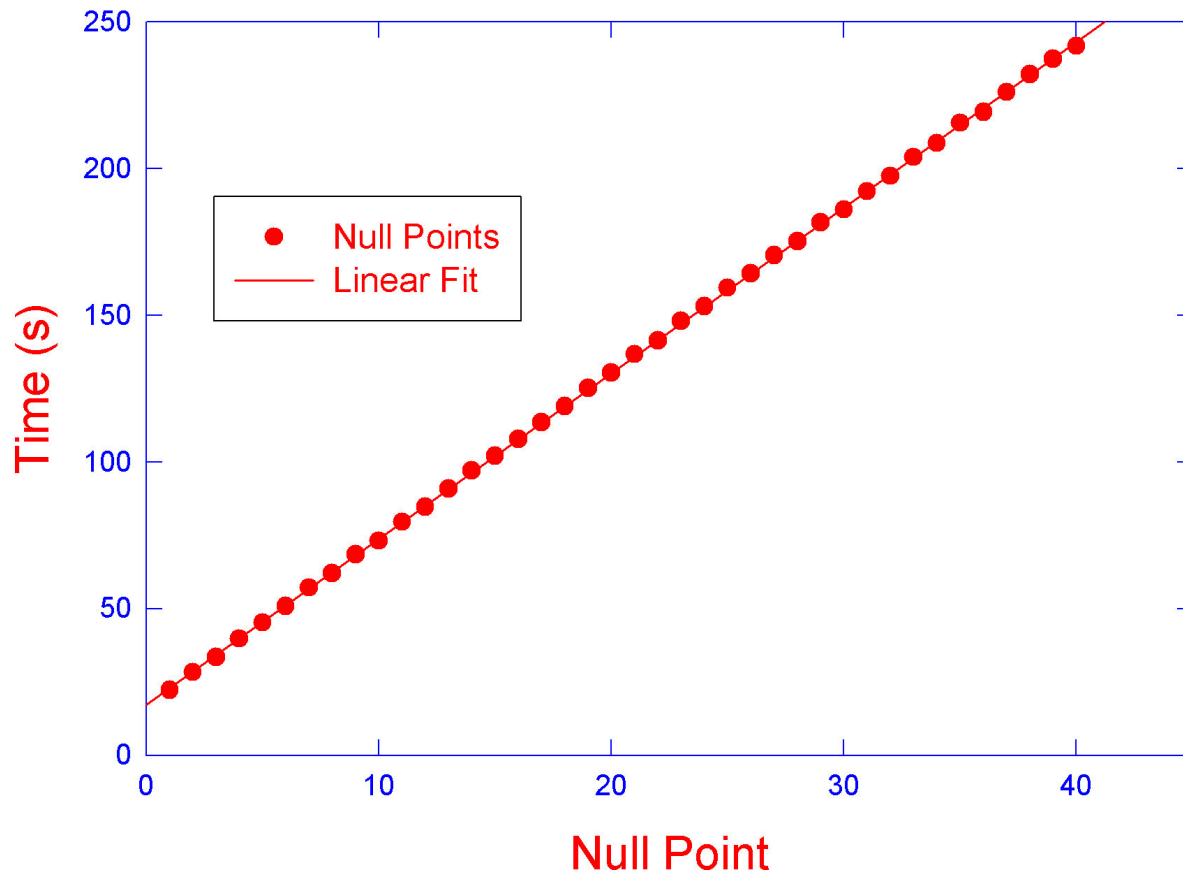
Because the absence of color is easiest to identify, it is straightforward to determine times when the null points occur in the difference image. Figure H–18 shows a plot of time versus null point number obtained from the difference video. The points fall on a straight line having a slope of 5.647 seconds \pm 0.008 seconds (95 percent confidence interval). Because the building passes through a null point twice during a single full oscillation, the period required for a single oscillation is 11.3 seconds.

Figure H–18. The time when null points are observed in the difference video following the plane strike on WTC 2 are plotted versus the null point number. The points fall on a very good straight line having a slope of 5.647 seconds \pm 0.008 seconds.

The measured oscillation period is consistent with measurements that are available from WTC 1 that yielded periods of 10.9 seconds in the east-west direction (averaged over a 9-year period that ended in 1993) and 11.6 seconds in the north-south direction (averaged over a 14-year period that also ended in 1993). The cores of the two towers were oriented perpendicular to each other so the motion monitored here should be comparable to the east-west direction of WTC 1.
